LAWRENCE
LIVERMORE
NATIONAL
LABORATORY

LLNL-TR-648143

A Visual Description of the Concrete Exterior of the Cactus Crater Containment Structure

October 2013

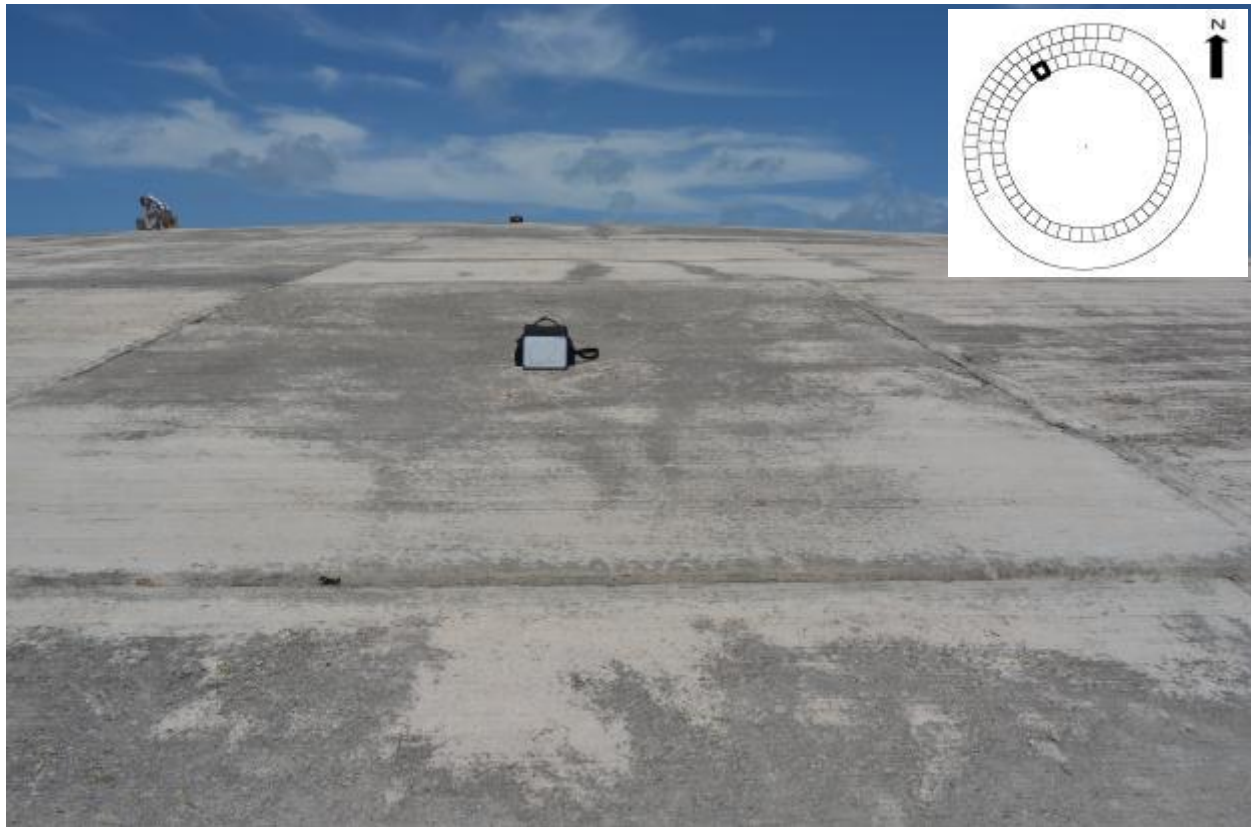
CAP SECTION LOCATION: Panel C3

No significant or obvious interior cracks extending across the top of the panel. Rooting vegetation removed from along the panel seams.

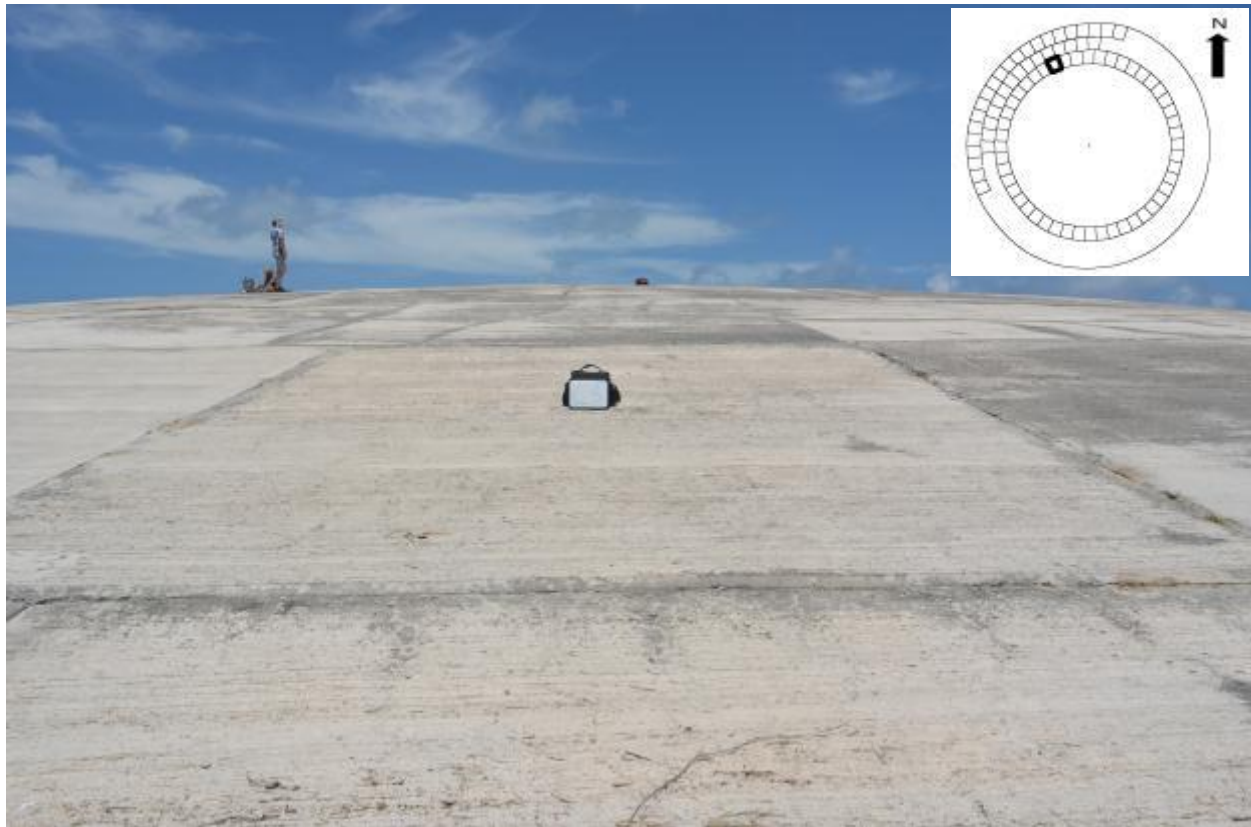
CAP SECTION LOCATION: Panel C4

No significant or obvious interior cracks extending across the top of the panel. Rooting vegetation removed from along the panel seams.

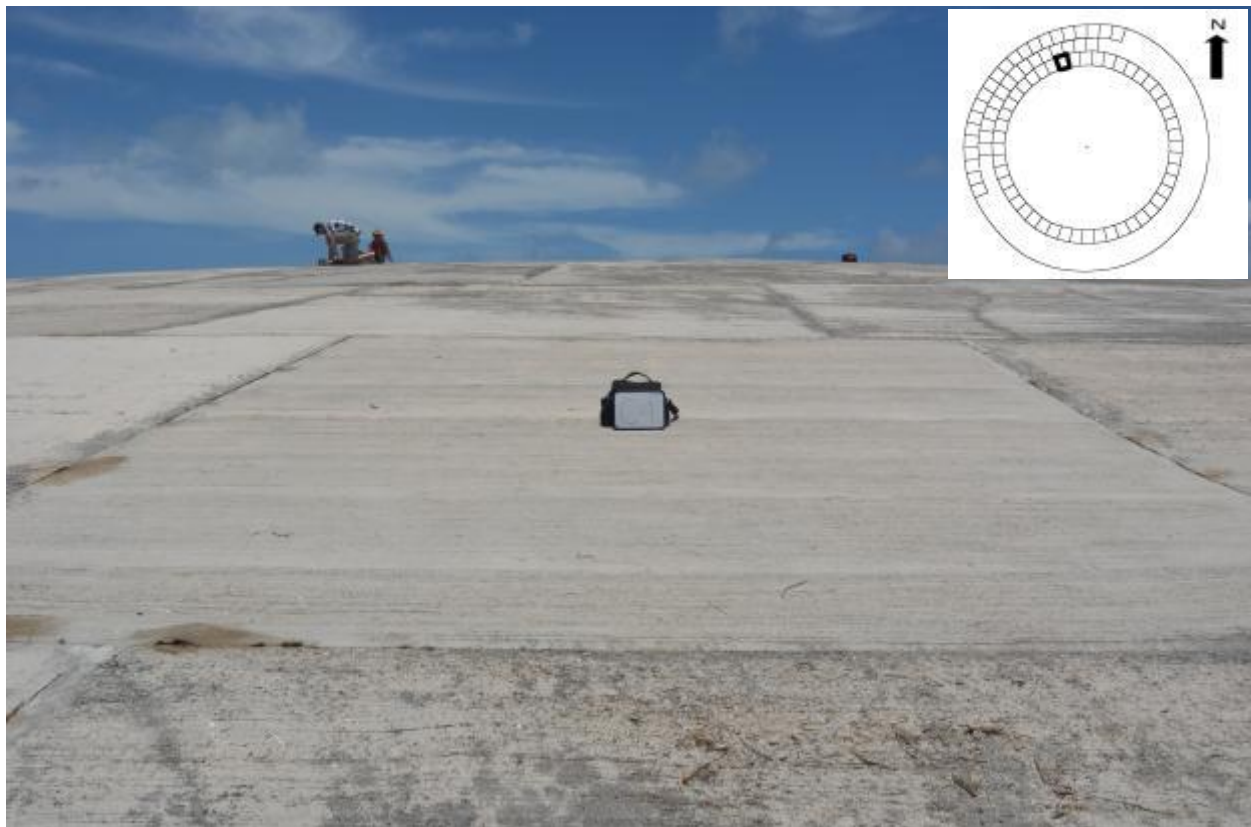
CAP SECTION LOCATION: Panel C5

No significant or obvious interior cracks extending across the top of the panel. Rooting vegetation removed from along the panel seams. Some minor spalling of concrete observed in the upper left-hand corner and along the upper seam overlapping the D panels above.

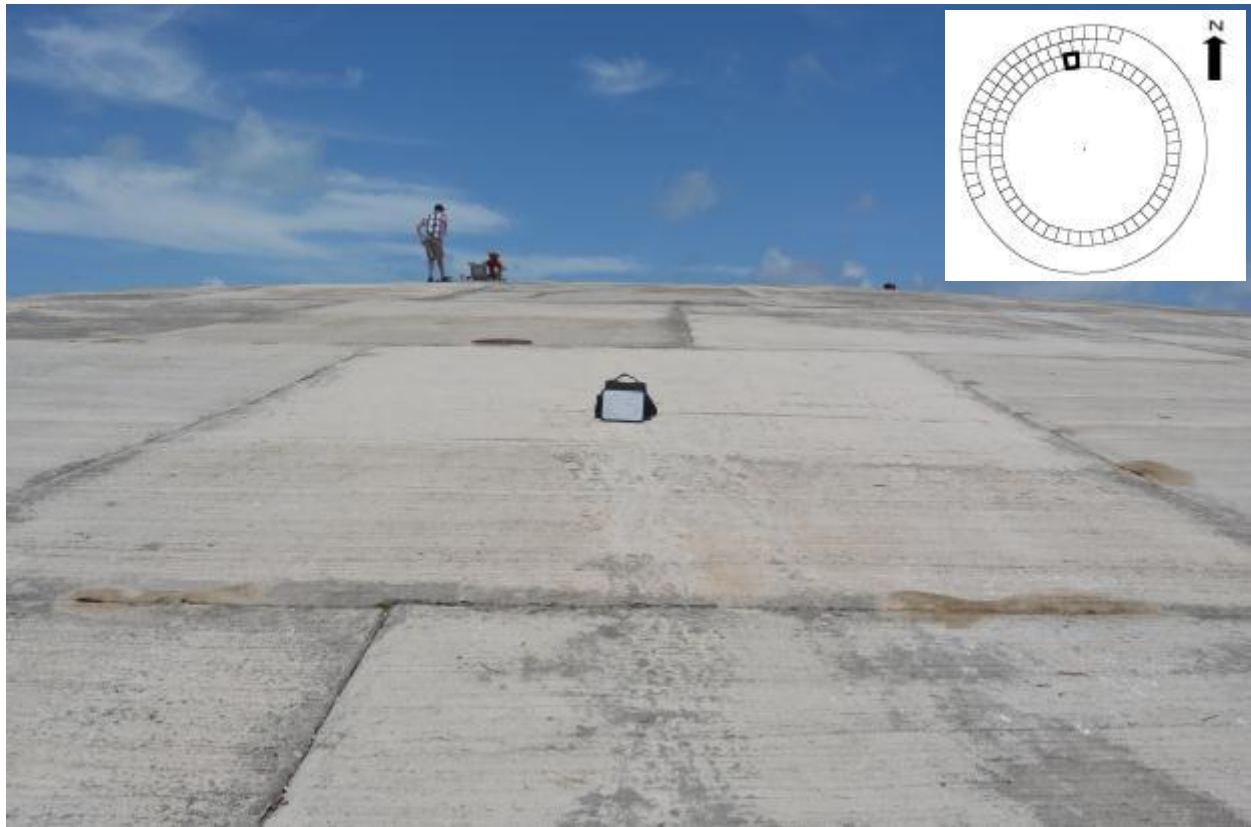
CAP SECTION LOCATION: Panel C6

No significant or obvious interior cracks extending across the top of the panel. Rooting vegetation removed from along the panel seams.

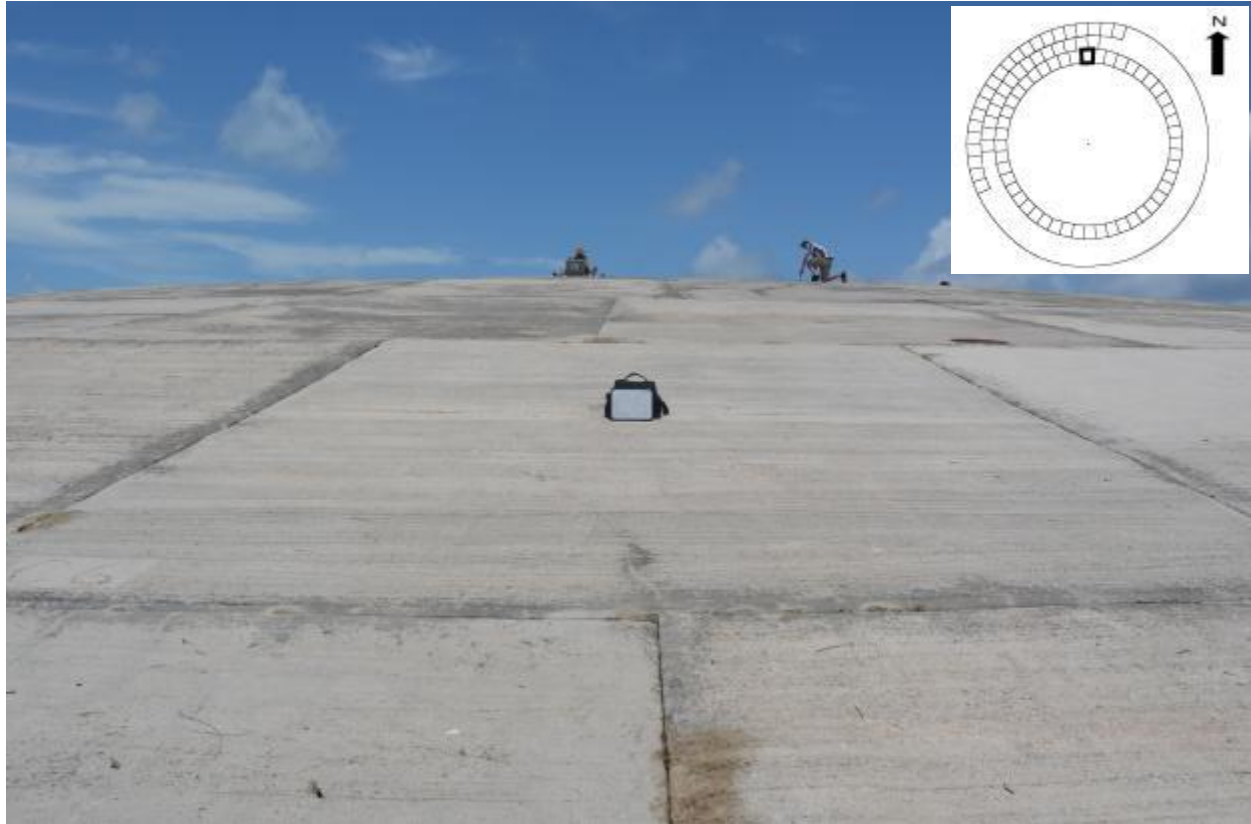
CAP SECTION LOCATION: Panel C7

No significant or obvious interior cracks extending across the top of the panel. Panel appears rough and weathered. Rooting vegetation removed from along the panel seams. Some minor spalling of concrete observed in the upper left-hand corner of the panel.

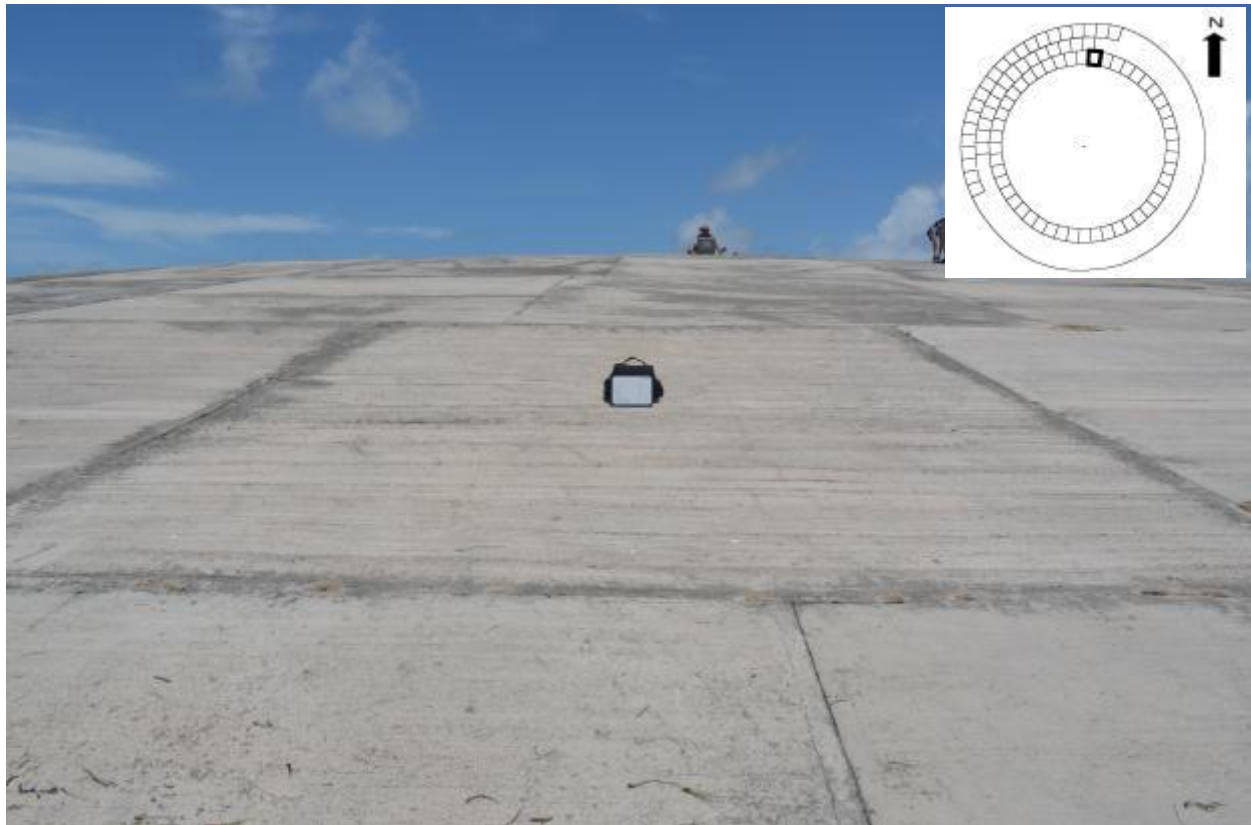
CAP SECTION LOCATION: Panel C8

No significant or obvious interior cracks extending across the top of the panel. Rooting vegetation removed from along the panel seams.

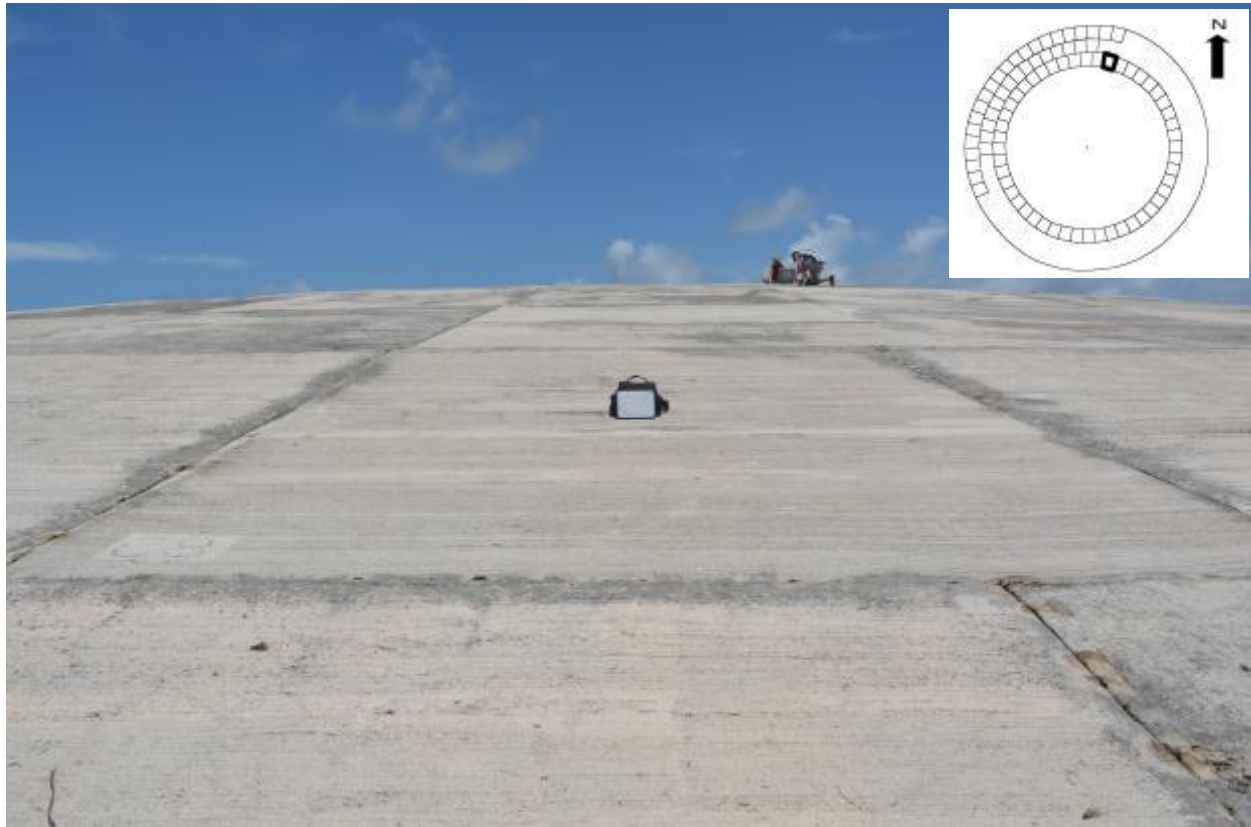
CAP SECTION LOCATION: Panel C9

No significant or obvious interior cracks extending across the top of the panel. Rooting vegetation removed from along the panel seams.

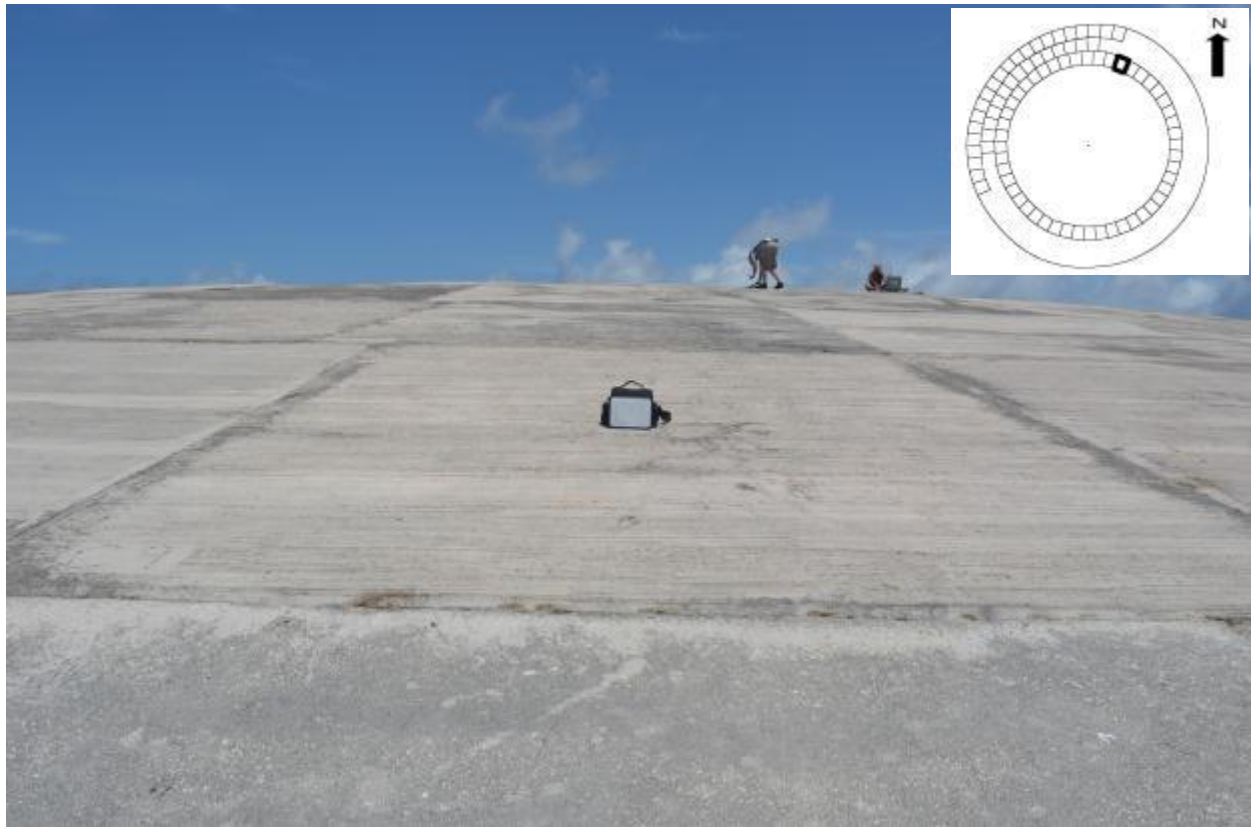
CAP SECTION LOCATION: Panel C10

No significant or obvious interior cracks extending across the top of the panel. Rooting vegetation removed from along the panel seams.

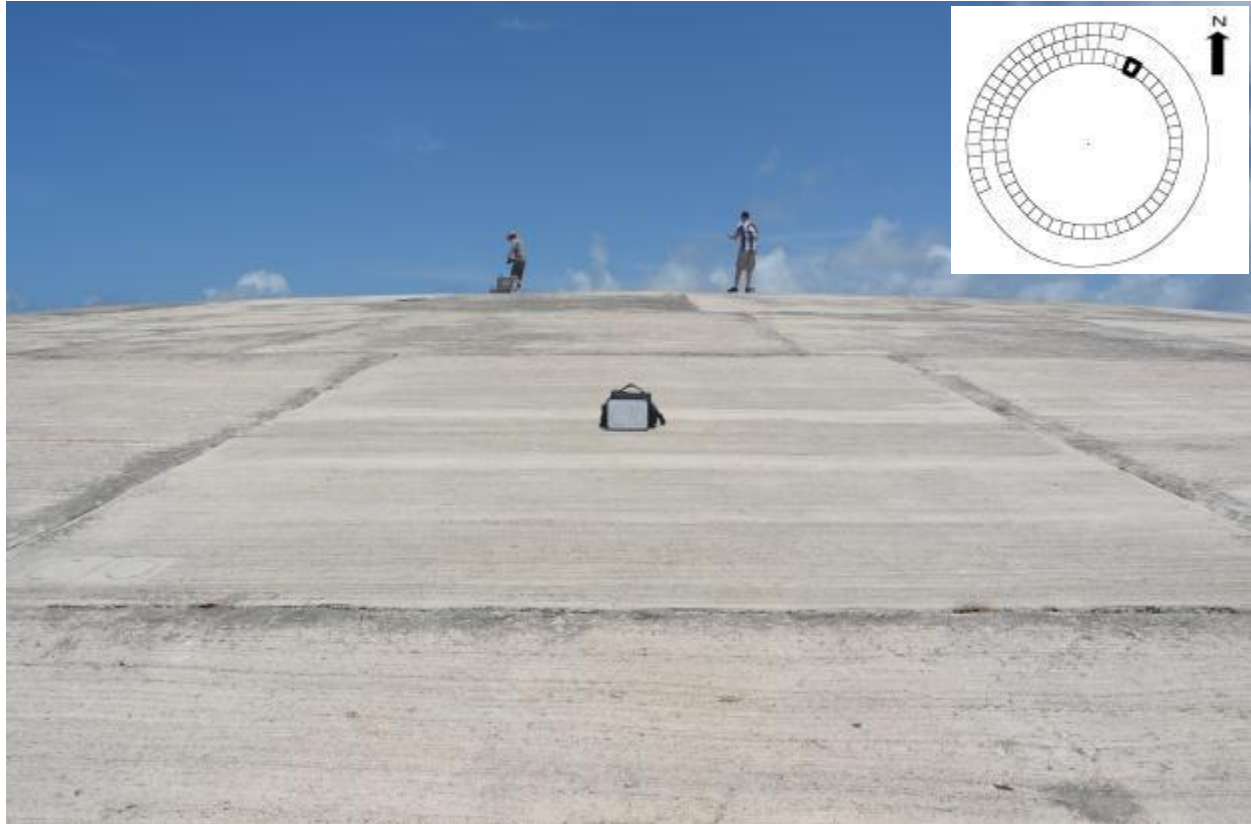
CAP SECTION LOCATION: Panel C11

No significant or obvious interior cracks extending across the top of the panel. The panel has a rough and weathered appearance. Rooting vegetation removed from along the panel seams.

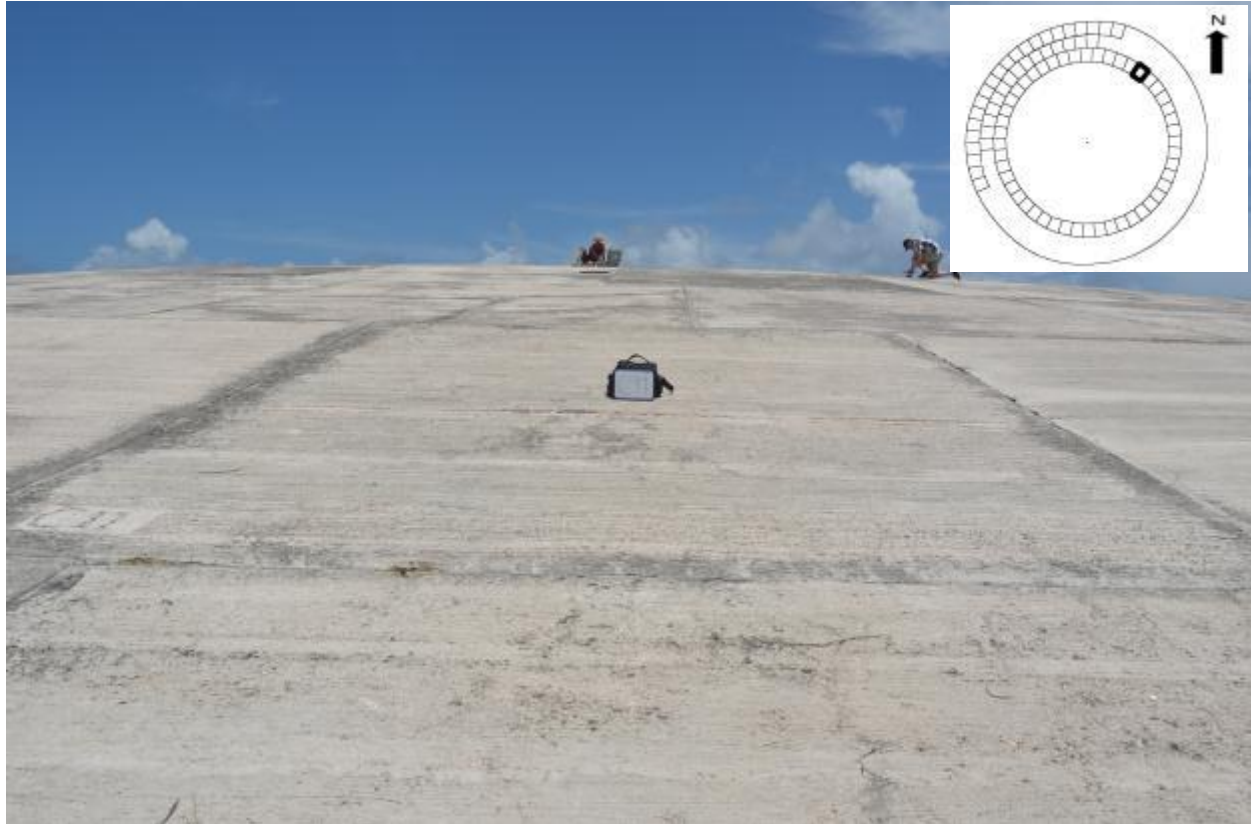
CAP SECTION LOCATION: Panel C12

No significant or obvious interior cracks extending across the top of the panel. Some minor spalling/chipping of concrete observed in the lower left-hand corner of the panel.

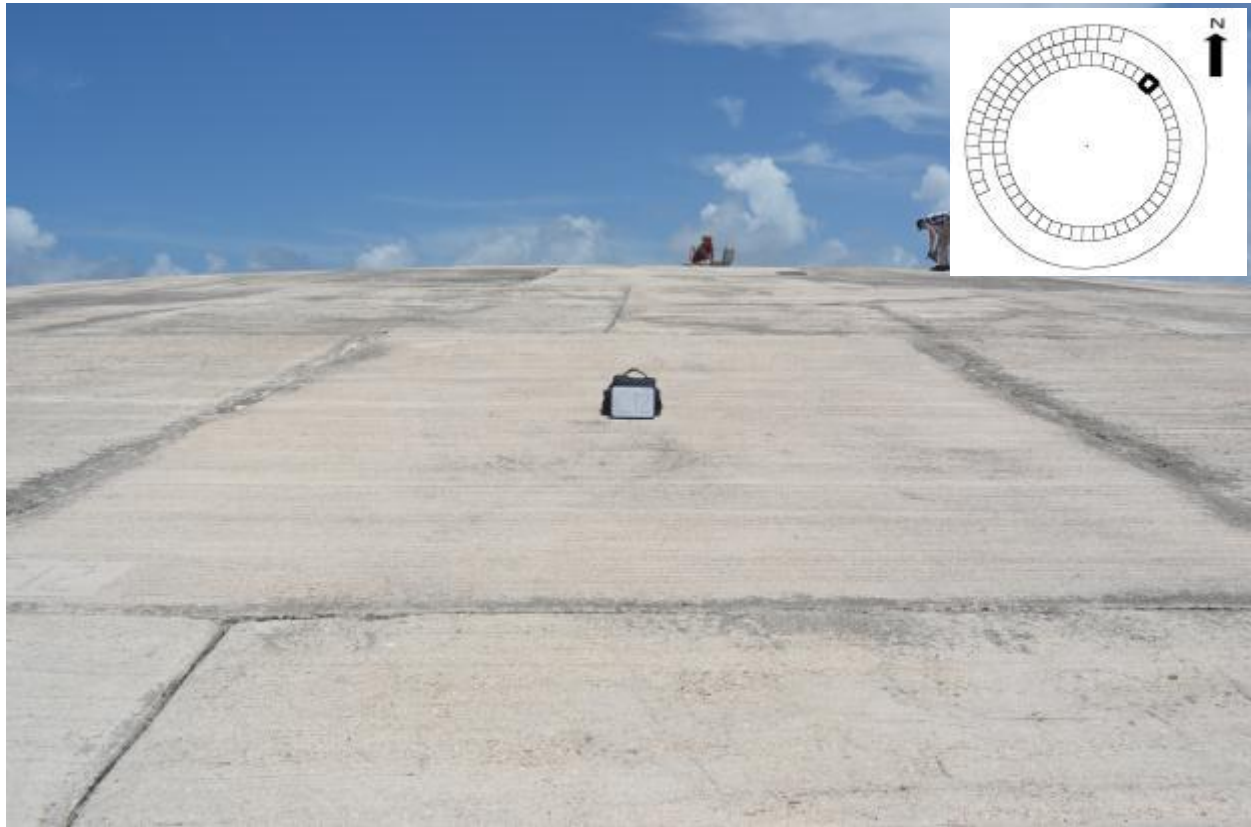
CAP SECTION LOCATION: Panel C13

No significant or obvious interior cracks extending across the top of the panel. The panel has a rough and weathered appearance.

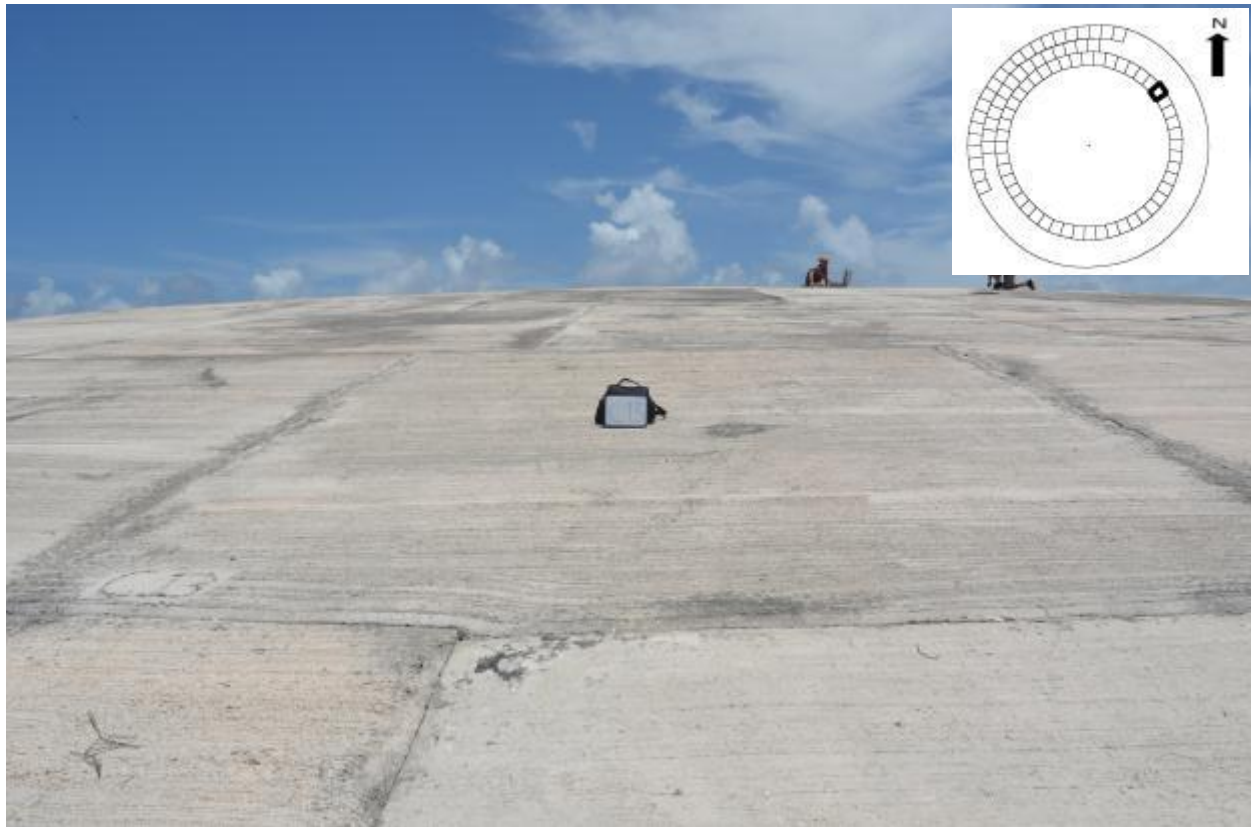
CAP SECTION LOCATION: Panel C14

No significant or obvious interior cracks extending across the top of the panel with exception of a small void found in the concrete app. 2 centimeters deep and about 2 x 1.5 centimeters in area. Rooting vegetation removed from along the panel seams. This panel contains a filled drill-hole (CD-12) from the 1980 NAS investigation.

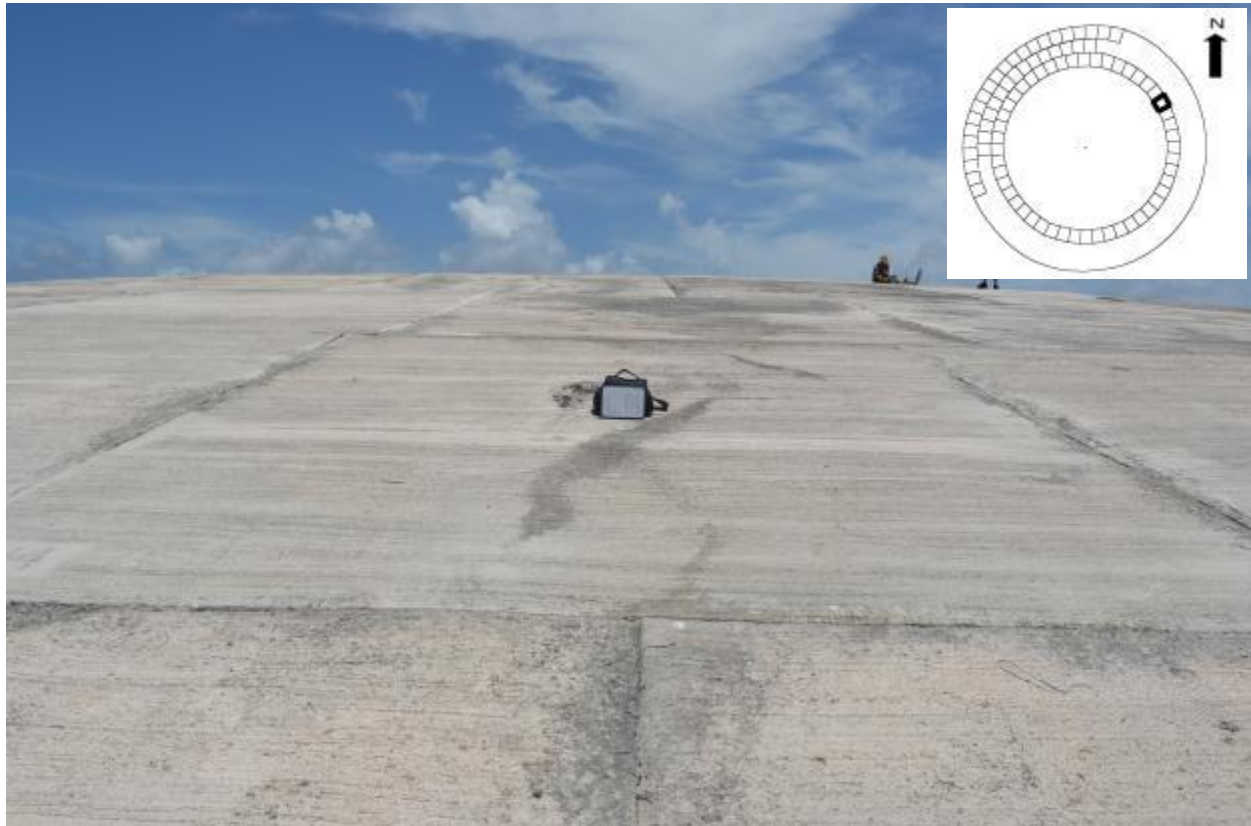
CAP SECTION LOCATION: Panel C15

No significant or obvious interior cracks extending across the top of the panel. Some minor spalling/chipping of concrete observed in the lower and top left-hand corners of the panel.

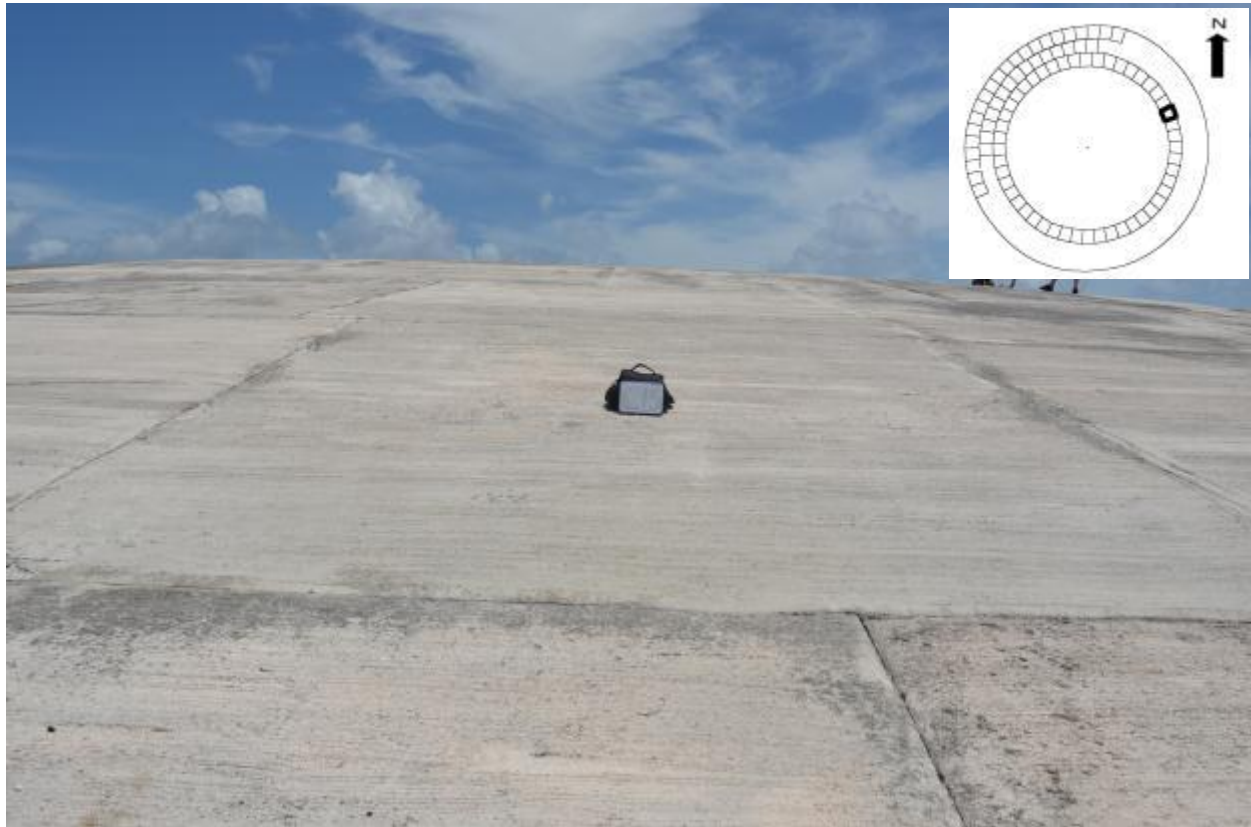
CAP SECTION LOCATION: Panel C16

Some spalling/chipping of concrete observed in the bottom left-hand and right-hand corners of the panel as well as along the bottom portion of the left seam and along the bottom seam adjacent to intersecting corners between panel B19 and B20. Spalling of concrete was also evident along the central portion of the top seam. A surface crack was observed traversing across the segment at a mid-point up the panel.

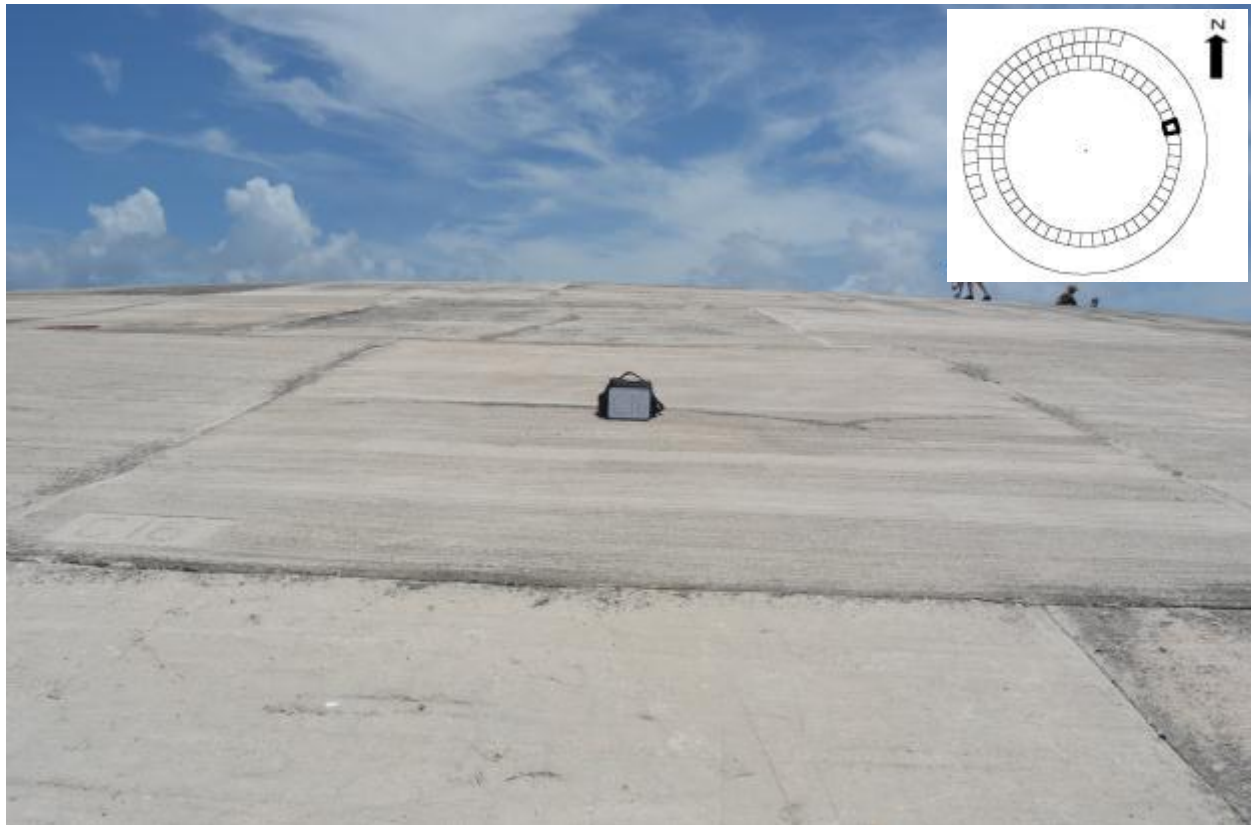
CAP SECTION LOCATION: Panel C17

No significant or obvious interior cracks extending across the top of the panel. Rooting vegetation removed from along the panel seams. Some minor spalling/chipping of concrete observed in the lower right-hand corner of the panel.

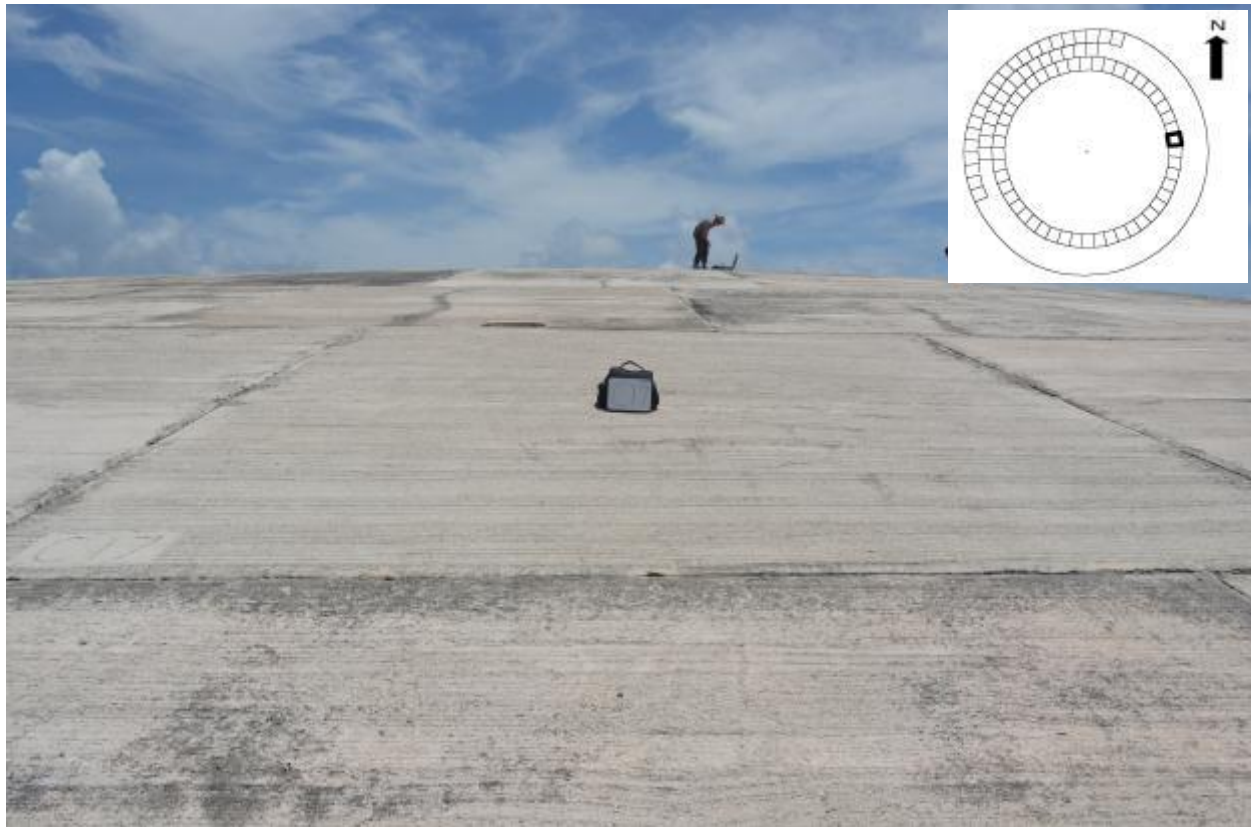
CAP SECTION LOCATION: Panel C18

No significant or obvious interior cracks extending across the top of the panel. The panel has a rough and weathered appearance, especially in the upper portion of the panel. Rooting vegetation removed from along the panel seams.

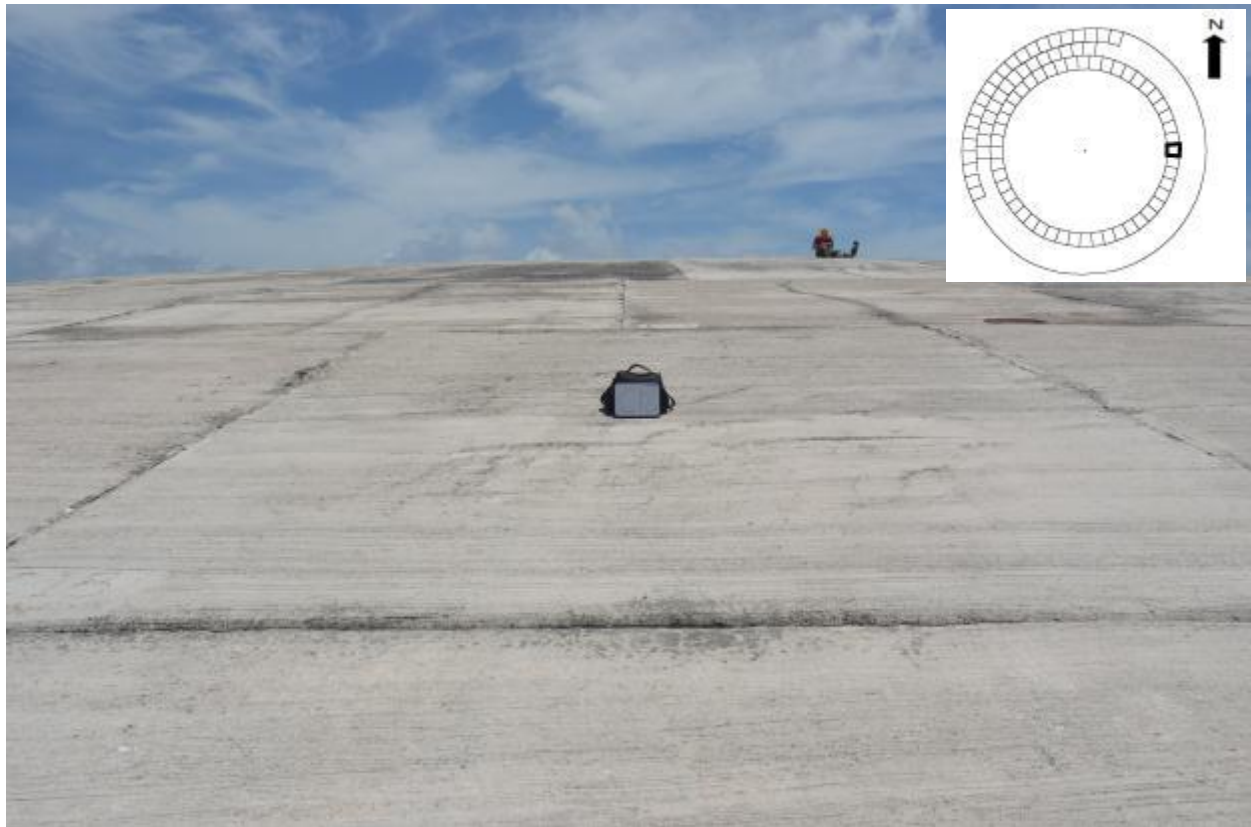
CAP SECTION LOCATION: Panel C19

No significant or obvious interior cracks extending across the top of the panel. Some minor spalling/chipping of concrete observed in the lower right-hand corner of the panel. The right-hand side of the panel appears to be slightly undulated – perhaps due to panel settlement. This is supported by the observation that there appears to be more separation (i.e., a larger gap) along the seams compared with any adjacent panels.

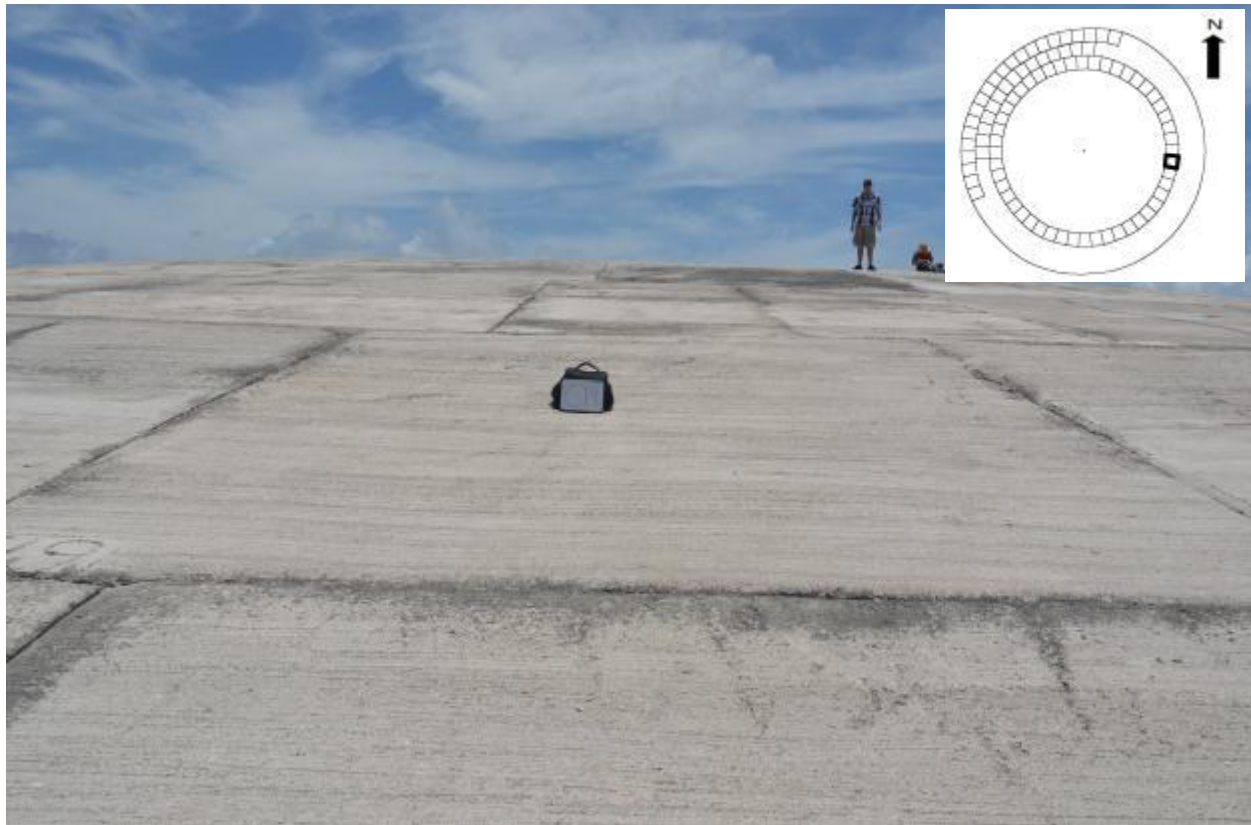
CAP SECTION LOCATION: Panel C20

No significant or obvious interior cracks extending across the top of the panel. The panel has a rough weathered appearance, especially across the upper portion of the panel. Some minor spalling/chipping of concrete observed in the upper right-hand corner, and along the bottom seam of the panel – especially around the intersecting corner with panel B24/B25 on the ring row below.

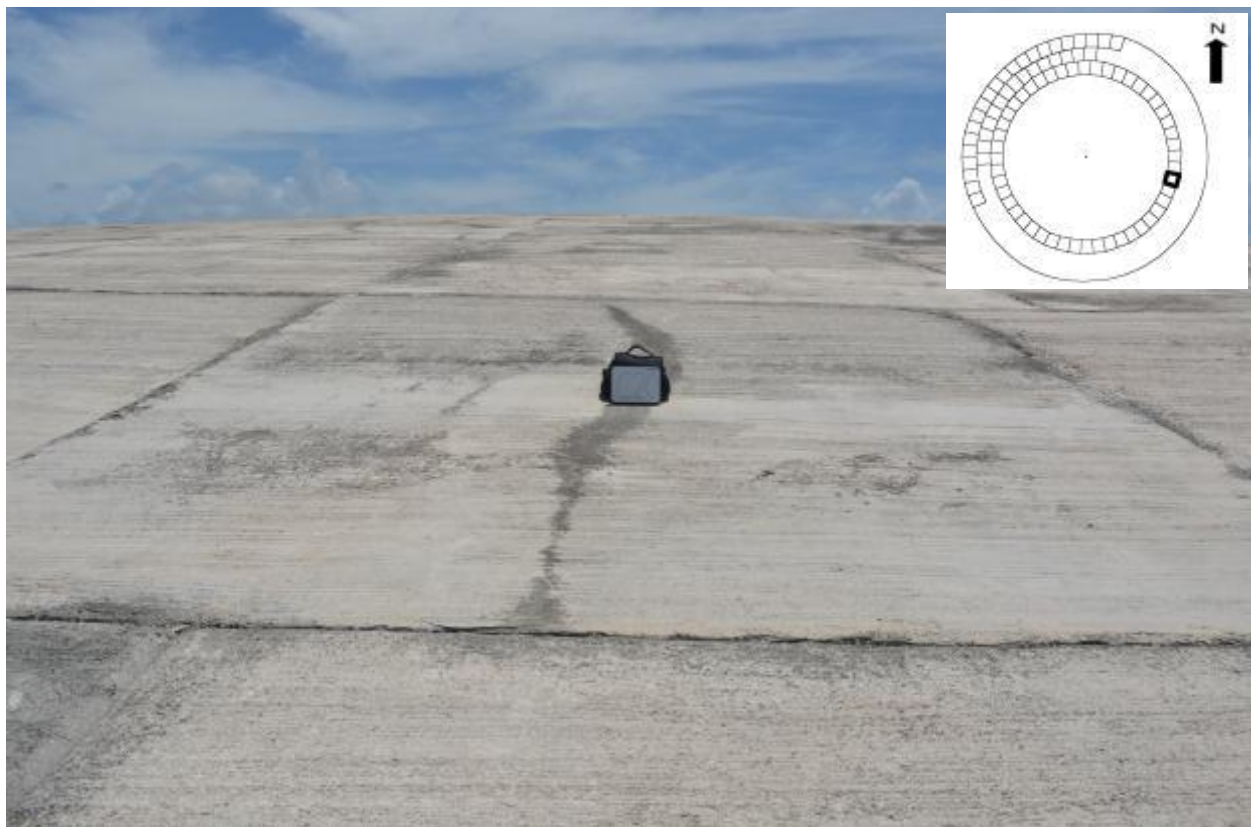
CAP SECTION LOCATION: Panel C21

No significant or obvious interior cracks extending across the top of the panel. Minor spalling/cracking of concrete observed in the upper left-hand corner and along the right side of the bottom seam.

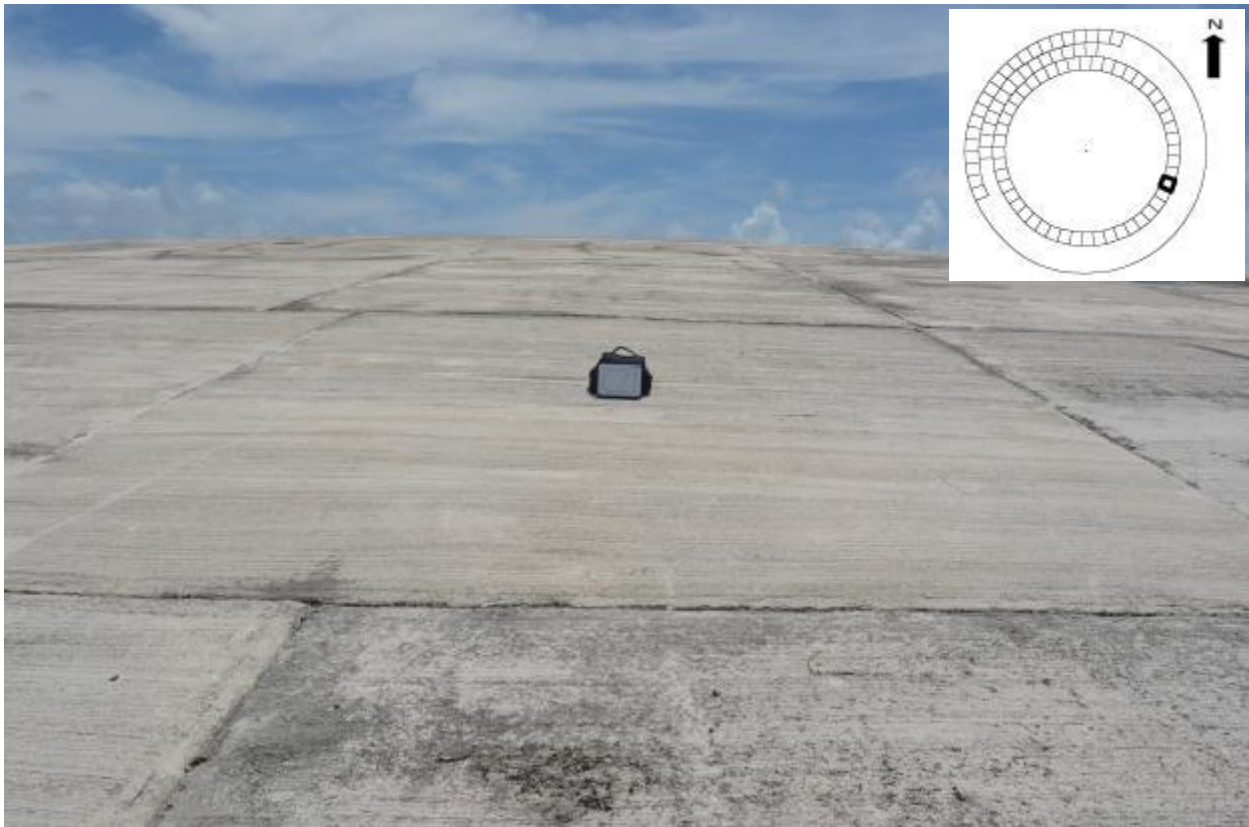
CAP SECTION LOCATION: Panel C22

Upper sections of the panel have a slightly more rough and weathered appearance. Minor interior cracks extending across the top of the panel. Some spalling/cracking of concrete observed along the left side of the bottom seam.

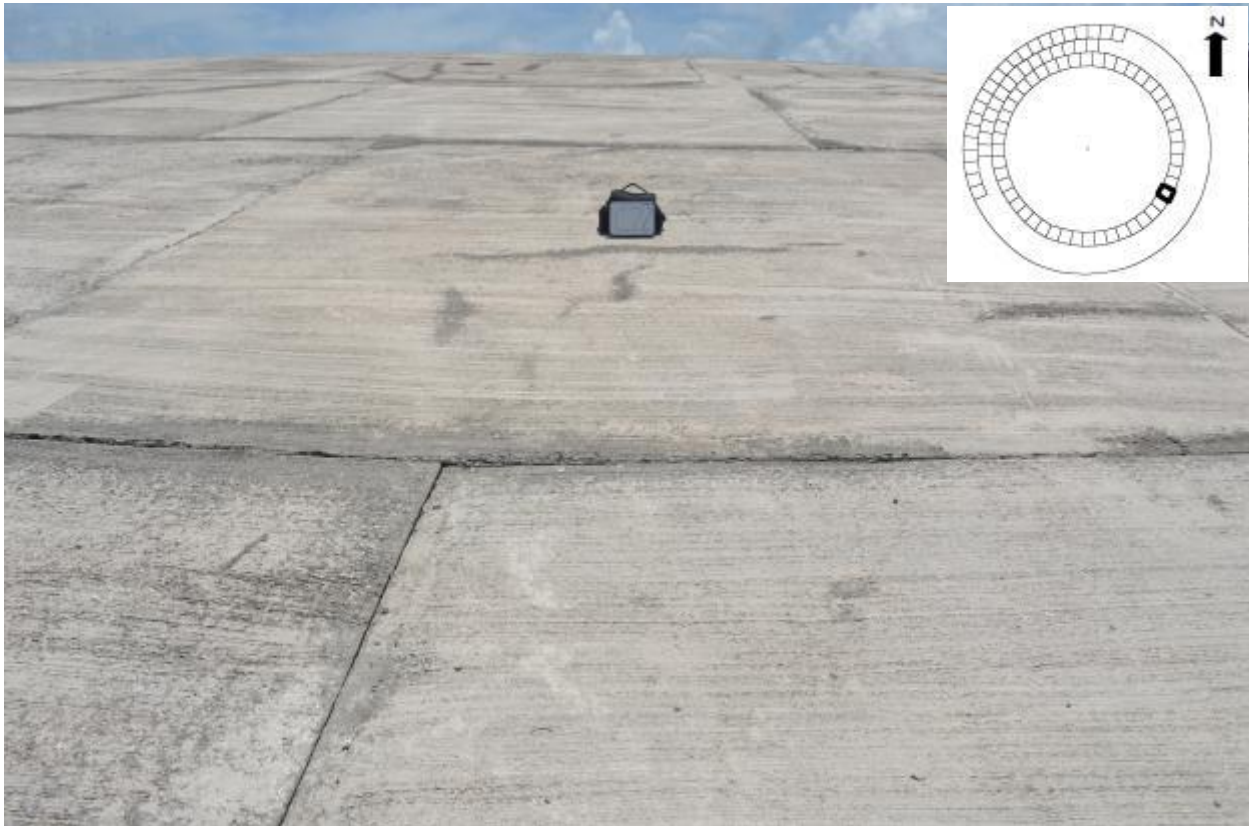
CAP SECTION LOCATION: Panel C23

No significant or obvious interior cracks extending across the top of the panel. The panel has a slightly more rough and weathered appearance. The cracks along the seam lines appear to be deeper and more obvious.
